REPORT ON INDUSTRY ATTACHMENT
AT
ATHI WATER WORKS DEVELOPMENT AGENCY
BY
PROF. JOEL KIBIIY

DEPARTMENT OF CIVIL AND STRUCTURAL ENGINEERING
SCHOOL OF ENGINEERING
MOI UNIVERSITY

MARCH 2020

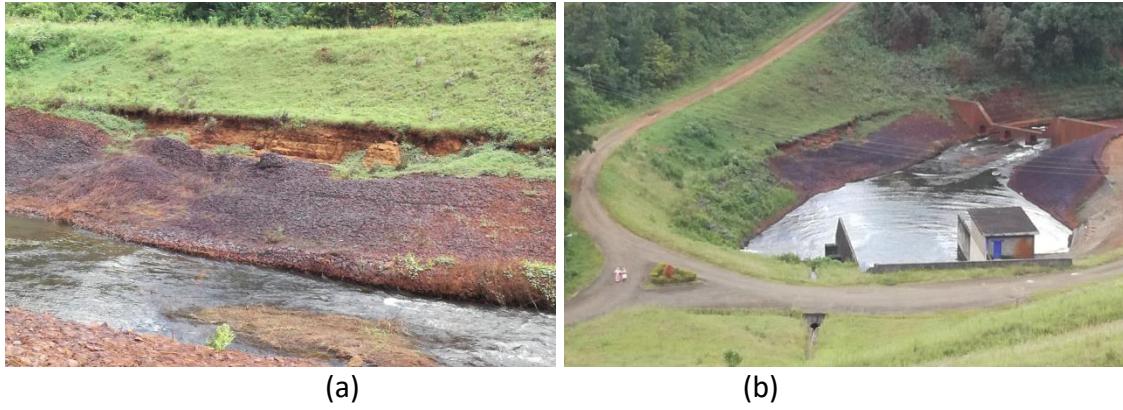
- a. The river bank protection provided at the dam outlet area consisting of gabions has failed (Plate 5). The failure may be attributed to the energy of water released from the outlet as overflow and/or sediment scoring. It can be seen in Plate 5(b) that the point of failure lies in a straight line with the flow path of water from the outlet. This is, therefore, a problem with origins in the design of the outlet area.

Plate 5. Damaged river bank protection at the outlet area of Thika Dam

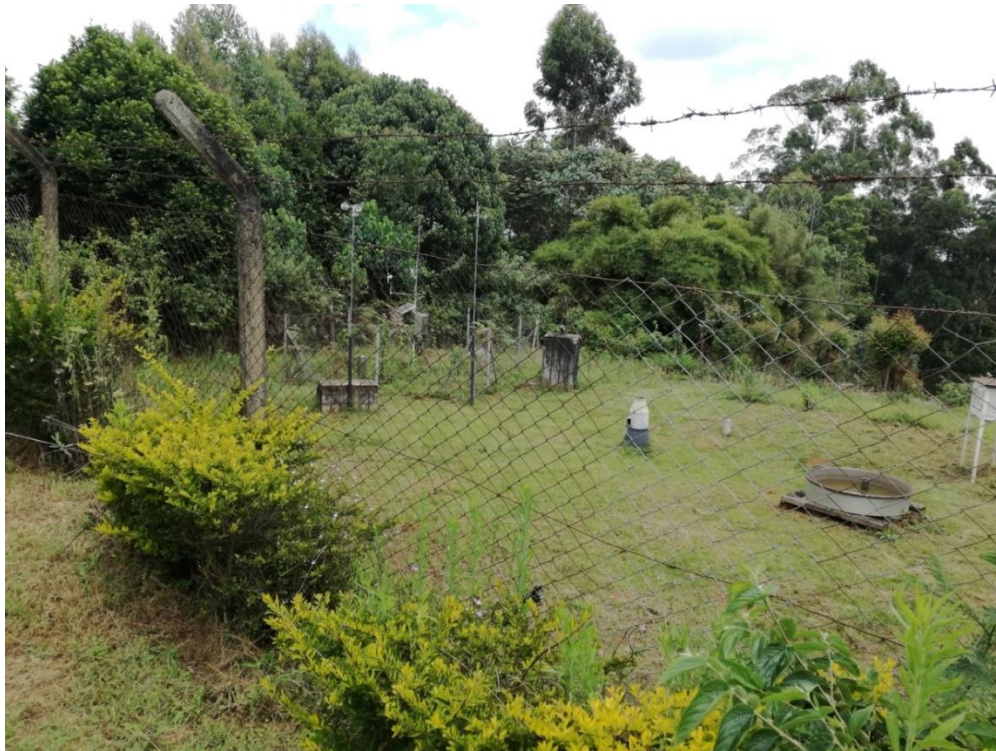
- b. The weather station at Thika Dam is bordered by trees that have overgrown the fence (Plate 6) and impact negatively on the functioning of some of the equipment at the station. The World Meteorological Organization (WMO) standards prescribe the distance and height of vegetation or other obstructions.

Plate 6. Weather station at Thika Dam

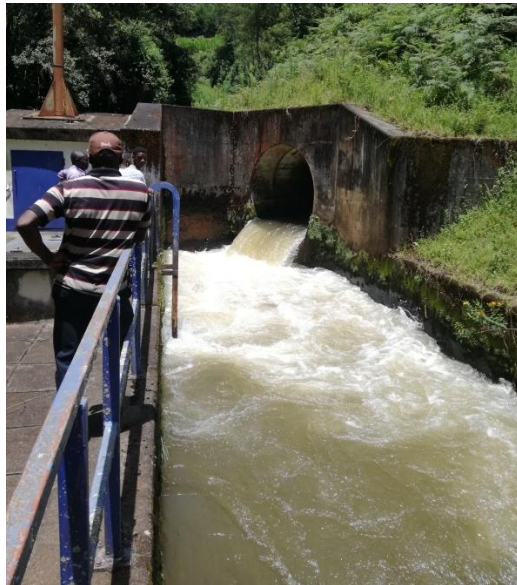
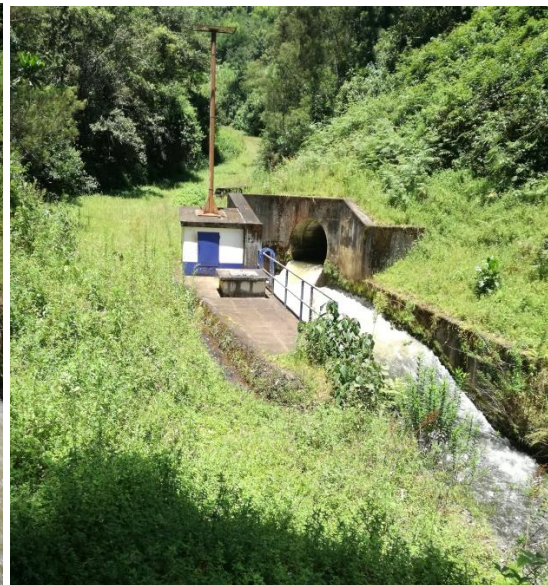
The existing gauging installations at the Chania outfall are shown in Plate 7. It can be seen that there is no outfall chamber and that there is also no measuring weir or flume. However, a stilling well is provided from where water levels are read.

Plate 7. Flow measuring installations at Chania outfall

It is also worth stating that if indeed there is a problem, it can be remedied by undertaking gauging by current meter and subsequently developing a rating curve. A site for flow gauging by current meter is so chosen that the flows may be assumed to constitute uniform flow.

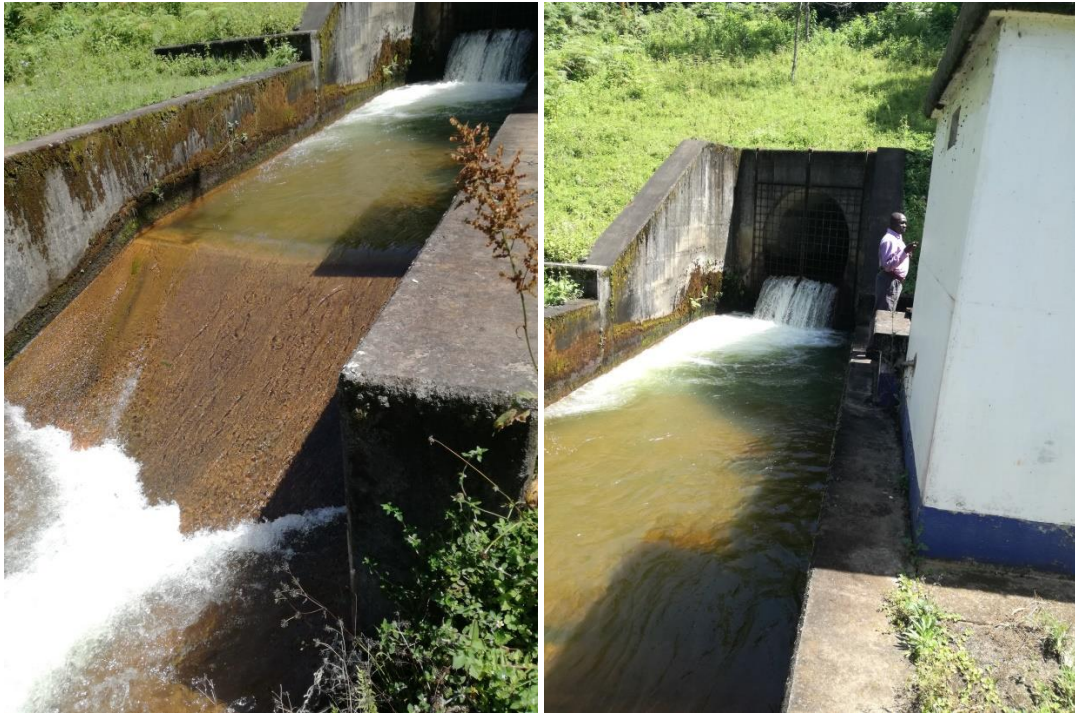
- ii. The situation is exactly the same at the Kiama outfall (Plate 8). A stilling well is provided immediately after the outfall (Plate 8b) for readings of water level but there is no stilling basin and there is neither a weir nor flume for flow measurement.

Plate 8. Flow measuring installations at Kiama outfall

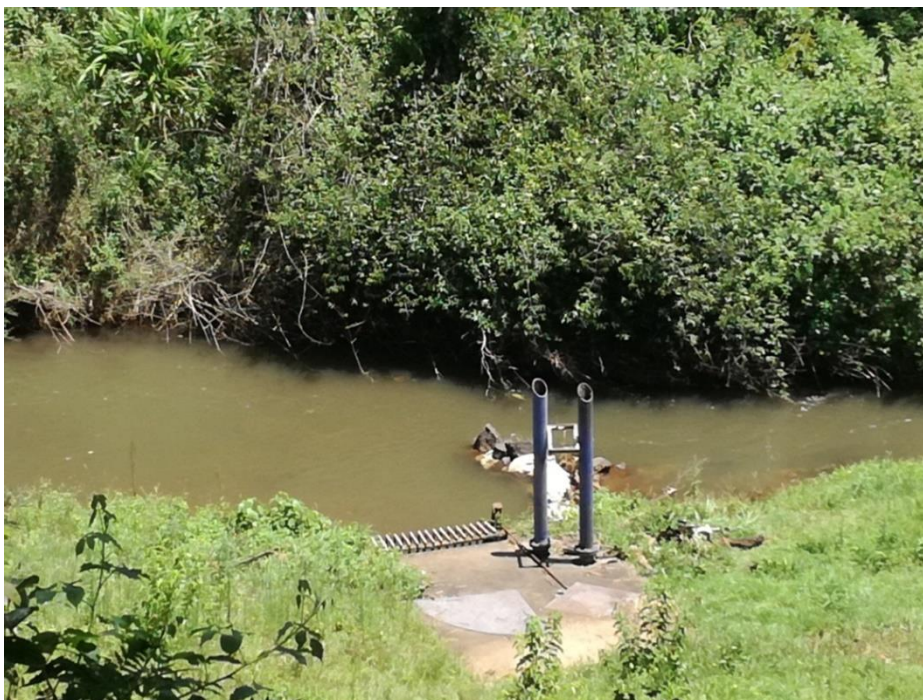
- iii. The intake from River Kimakia into the Thika Dam – Ng’ethu WTP System consists of a sealed chamber that leads the water into a tunnel (Plate 9). The amount of water abstracted was supposed to be monitored automatically and tele-transmitted by a solar-powered system now vandalised. The measuring flume or weir, if any, are enclosed in the chamber and thus precludes the possibility for or means for manual monitoring.

Plate 9. Intake chamber at River Kimakia

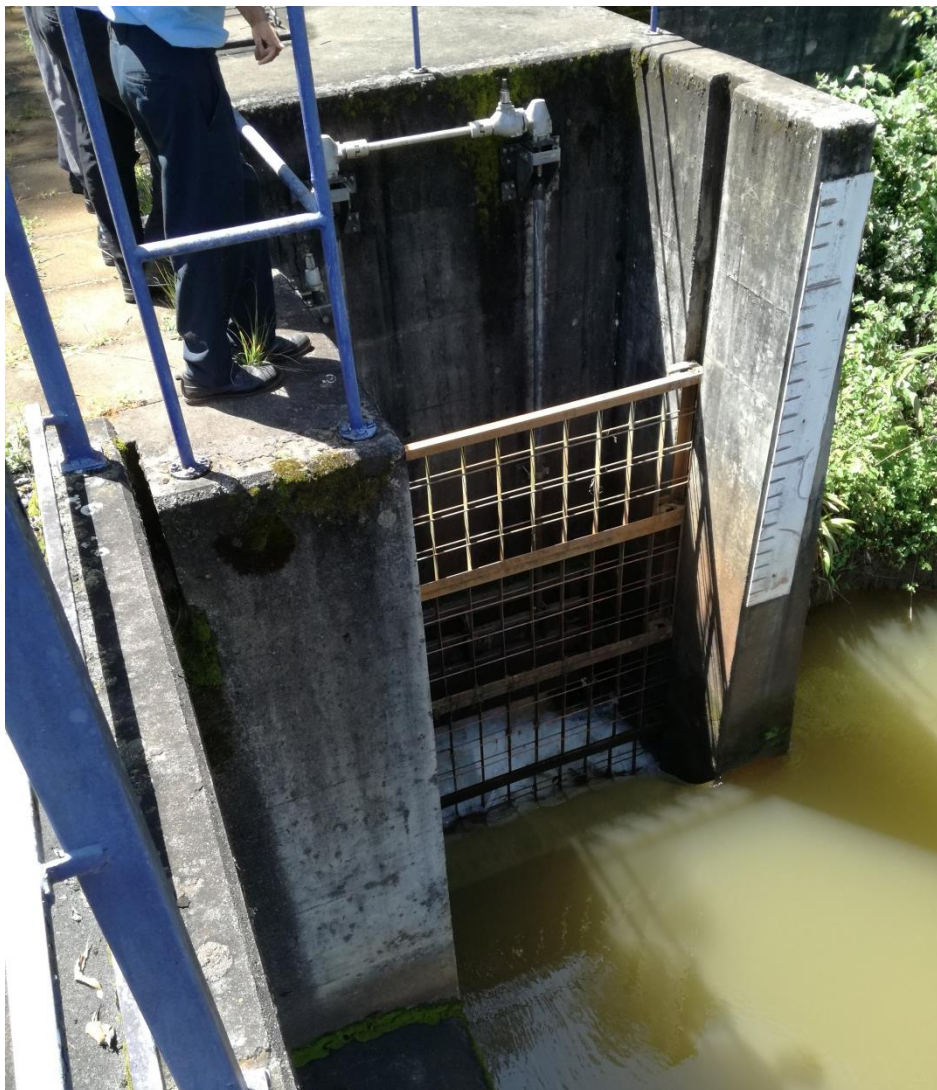
The intake from Kiama into the Kiama-Chania tunnel has flow measuring devices which are not capable of providing data for want of maintenance. Plate 10 shows the intake from at River Kiama.

Plate 10. Intake at River Kiama

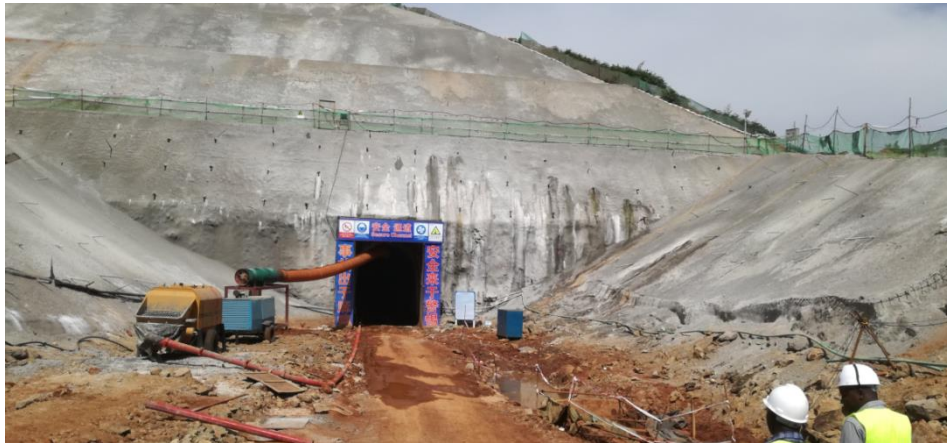
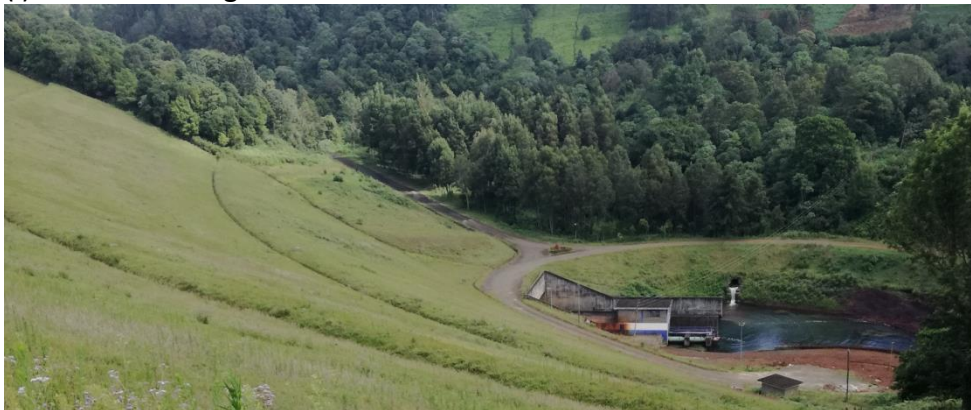
- b. The works are on an extensive site and varied in engineering terms of the disciplines. The supervision, however, seems to be thin on the ground. A strong supervisory team is necessary especially given that this is a fund-design and build contract.
- c. The materials laboratory n site is good. It is however, small and inadequate in scope.
- d. The natural slopes on the reservoir area are very steep and they raise the prospect of sliding once submerged.
- e. Environmental considerations are important for all works. A comparison of two solutions is given in Plate 11 for two finishes to slopes.

(i) concrete facing for the outlet of the tunnel at Karimenu II Dam

(ii) grassed downstream slopes of the Thika Dam

Plate 11. A comparison of environmental solutions

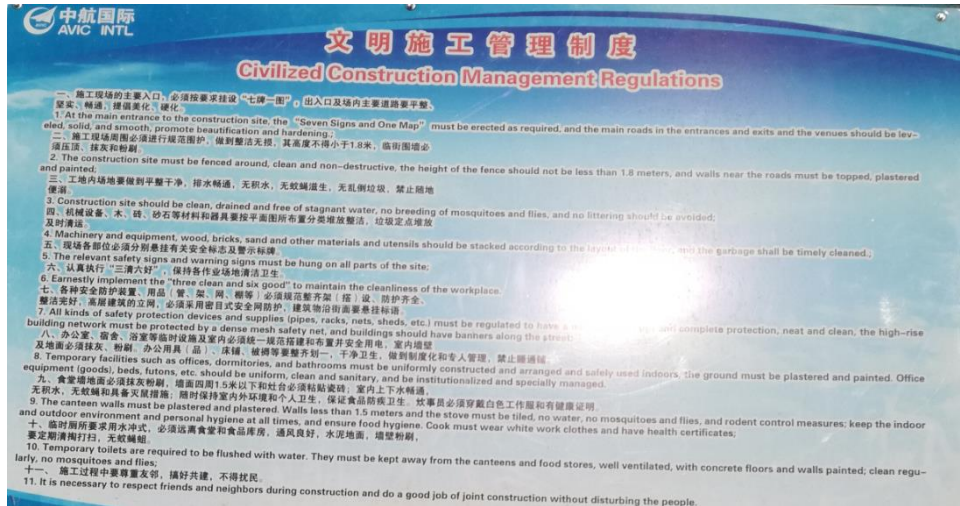
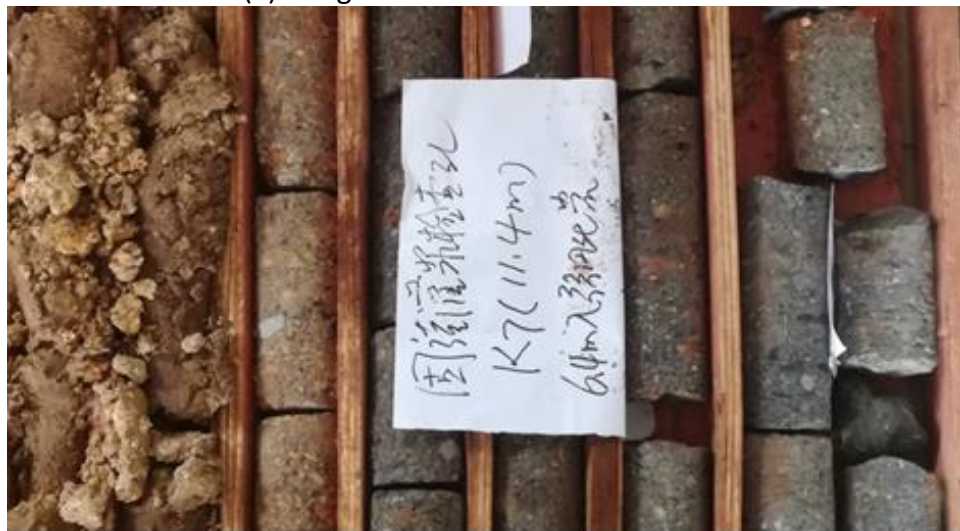
- f. Working language: there is an element of language barrier noticeable at site. In some cases it may be quite innocuous as in the notice in Plate 12 (a). In others, however, it may have long-term undesirable consequences as illustrated in the lab record on a set of core samples in Plate 12(b).

(a) A signboard at Karimenu II Dam site

(b) A geological log record at Karimenu II Dam site laboratory

Plate 12. Language need not be a barrier

The services of a language expert could be helpful for proper communication and records.
