REPORT ON INDUSTRY ATTACHMENT
AT
ATHI WATER WORKS DEVELOPMENT AGENCY
BY
PROF. JOEL KIBIIY

DEPARTMENT OF CIVIL AND STRUCTURAL ENGINEERING
SCHOOL OF ENGINEERING
MOI UNIVERSITY

MARCH 2020

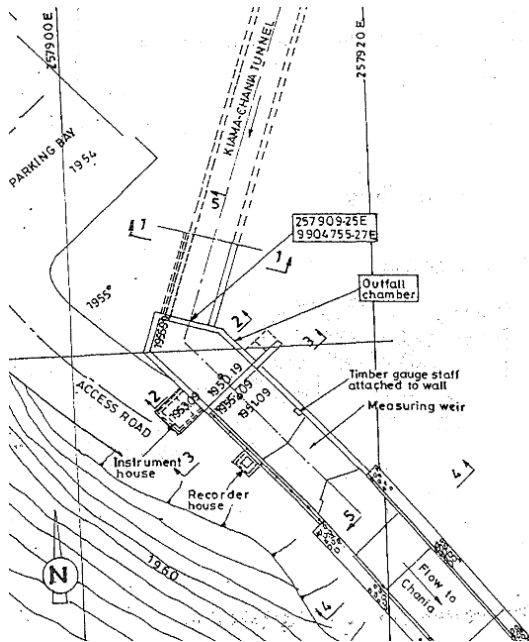
Figure 2. Plan for gauging installations at Chania outfall

- c. Discharge measuring installations at the various points along the Thika dam – Ng’ethu WTP System seem to suffer from a common defect that brings into question the reality of the readings. Flow measurement is based on energy principles for flow over weirs or flumes. The situation is explained below.
 - i. The plan for the gauging installations at the Chania outfall is shown in Figure 2. It incorporates an outfall chamber which is essentially a stilling basin, and a measuring weir – which has been drawn as a flume.

The existing gauging installations at the Chania outfall are shown in Plate 7. It can be seen that there is no outfall chamber and that there is also no measuring weir or flume. However, a stilling well is provided from where water levels are read.
